CONDENSATION IN MANUFACTURED HOUSING

MUNICIPAL AFFAIRS

February, 1987

Tang G. Lee, MRAIC
Calgary, Alberta

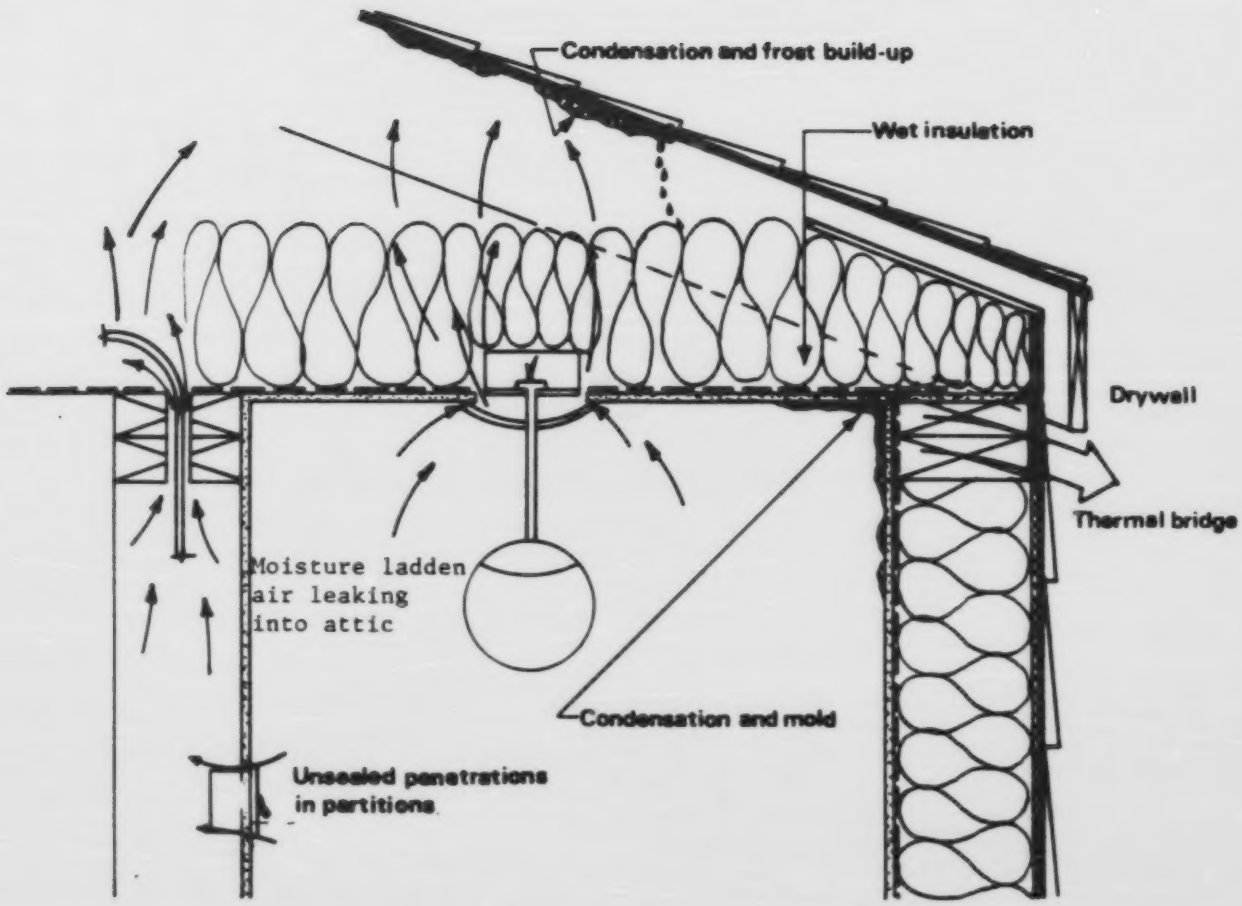
FIG. 2: Air leakage and thermal bridging in ceiling

Another area of thermal bridging in a mobile home is located at the wall and ceiling junction where condensation is generally most noticeable. The double top plates, and the reduction in depth of insulation necessary to maintain a venting space in the attic increases the thermal conductivity in this location (see Figure 2 on page 13A). Although it is not a code requirement, many site-built houses have already incorporated raised eaves in order to increase the amount of insulation, but many mobile home manufacturers are unable to include this added feature for reasons of travel height restrictions. Our survey shows many of the ceilings and roof junctions of older mobile homes are colder, resulting in condensation damage such as staining of the ceiling.

With respect to the ceiling drywall extending across the top plates, one mobile home manufacturer believes this feature will act as a gasket or seal between the wall and ceiling. Furthermore, this practice accommodates the factory assembly process in the manufactured housing industry. The roofs of mobile homes are made on a jig and the entire assembly is placed into position on top of the home. Any inaccuracies between the roof and the walls would leave a

gap at the ceiling to wall junction. It may be advisable to reconsider the continued practice of extending the ceiling drywall over the exterior wall double plates. This configuration acts as a thermal bridge; the thermal conductivity of drywall is one third greater than wood. In this investigation, the wall and ceiling junctions exhibit some of the first signs of condensation and mold formation. However, on balance, the added costs and reduction in travel strength may not justify the potential marginal improvement, particularly in light of the new ventilation requirements and prevailing use of 38 x 140 (2" x 6") wall construction.

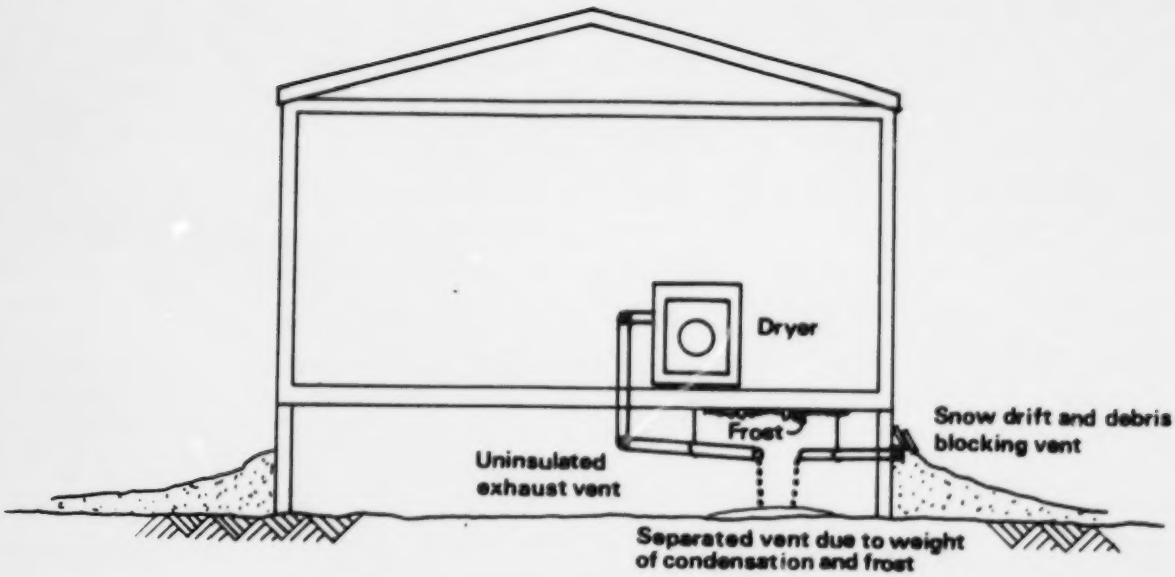
FIG. 5: Clothes drier exhaust ducting

Field visits to a number of mobile homes revealed some homes have ineffective clothes drier exhaust vents. This was evident by the amount of lint scattered throughout the house. Upon further inspection, the discharge grille on the exterior was often found to be blocked by a snow drift or other debris piled against the grille. In some crawl spaces examined, clothes drier exhaust ducts had sagged and/or separated. During cold periods, moisture laden air from the clothes drier condenses and freezes along the uninsulated exhaust duct in the crawl space. The weight of the accumulated water and frost cause the duct to break the supporting straps and tear the tape connecting sections of the ducts (See Figure 5 on page 33A). Stronger attachment can be achieved with screws but this is not permitted in the ducts where lint accumulation may occur around the protruding screws. Unchecked, the discharge from the drier fills the

Dryer
Frost
Snow drift and debris blocking vent
Uninsulated exhaust vent
Separated vent due to weight of condensation and frost

1. Clear existing monitor vents of obstructions.
2. Reconnect and/or repair damaged clothes drier ducting and vent to outside, not to crawl space.
3. Clear obstructions from blocking clothes drier grilles.
4. Clear obstructions from window weep holes.
5. Replace broken windows.
6. Repair bathroom fan (if noise is still a deterrent to its use, replace with a quieter fan and use resilient mounts or install a dimmer to slow fan speed).
7. Replace kitchen recirculating fan with venting model.
8. Add an entrance vestibule for the purpose of keeping snow and mud from entering the house.
9. Slope grade around the house.
10. Provide a groundcover moisture barrier.
11. Replace roof mounted vents with stack vents which extend at least 600 mm above the roof.

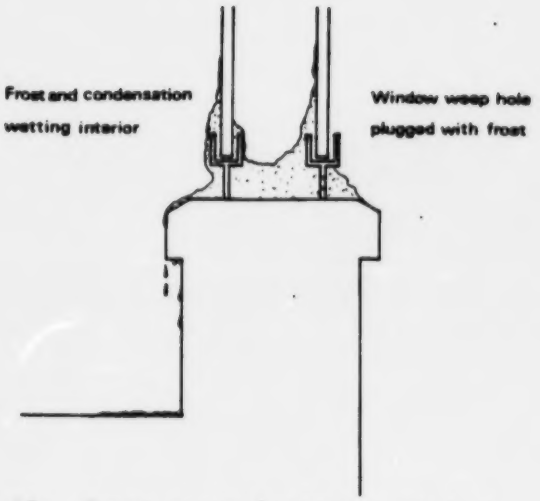
FIG. 10: Frost accumulation on windows

A small amount of condensation or frost on the glass pane of windows is normally tolerable and will not cause damage to the mobile home. The slight disadvantage of obscuring vision through the glass, and the remnants of water spots and dusting on the glass are perhaps the only concern to the occupants. If there is sufficient condensation on the windows to cause dripping, however, the potential for damages to the adjacent materials around the windows increases dramatically. Dripping water can affect the finish of the window sash and frame, particularly the sill, or it may overflow over the sill to damage the wall finish below as seen in Figure 10 on page 55.

Dripping water can also penetrate paint and stain finishes to rot the wood underneath a wood window and floor. The worst damage may be water seeping between joints and cracks on the window sill to wet the insulation, rust the nails and rot the wood studs and other building materials within the wall. The damaging effects of this process may not be apparent until it is too late for preventive measures. These effects will be discussed in the next chapter, Visible Condensation.

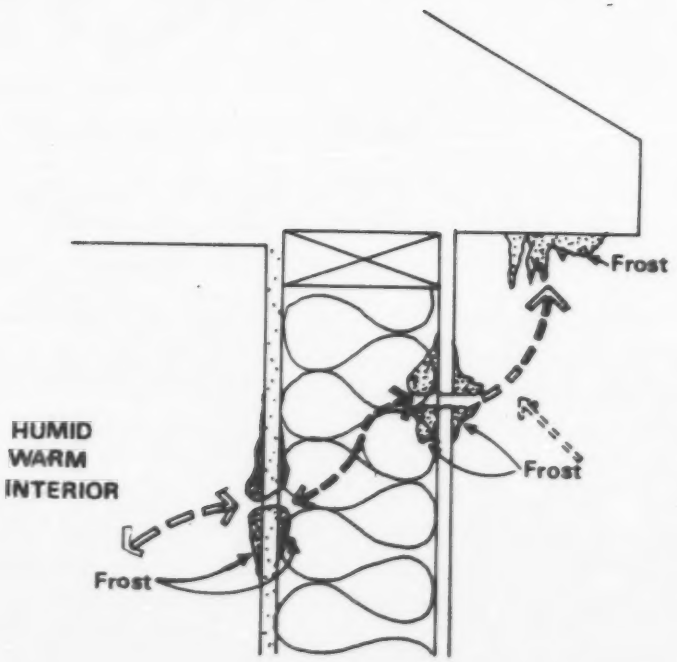
FIG. 11: Formation of frost around openings in an enclosure

Visible condensation may also occur on the exterior cladding. This occurs only on the side of the building with exfiltrating indoor air. As the warm moist indoor air flows through cracks and joints in the enclosure, the momentum may carry this air directly to the exterior even well after the moist air has reached its dew point temperature. Some of the saturated air will be carried off by the wind, but some will be blown against the cladding around the opening. The result is a build-up of frost around each opening where air has exfiltrated. The results are seldom damaging to the building as typical cladding materials can generally withstand water. It is likely that some of the outward-flowing air will condense within the building structure. Evidence of condensation and frost on the cladding may therefore indicate the possibility of concealed condensation.

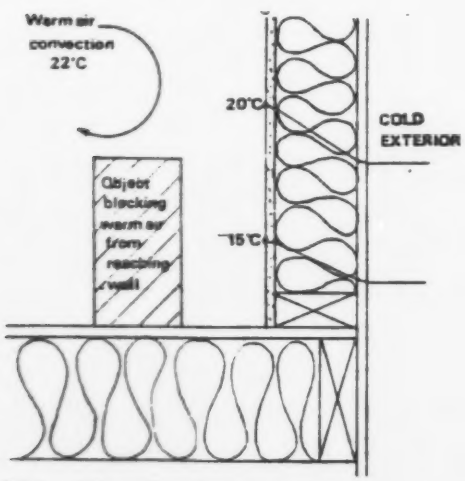
FIG. 12: Surface condensation due to lack of air flow

The difference between concealed condensation and visible condensation as was discussed in the previous chapter is that there is the danger that concealed condensation may not be noticed by the occupants until it is too late to prevent serious damage to the structure. Concealed condensation can occur simply by covering a window with curtains to restrict the warming effects of indoor air moving across the glass. This results in a cooler glass surface on which increased condensation will gather. Concealed condensation may occur in a similar manner on exterior walls behind furniture that insulates the wall from indoor heat but still allows the moist air to reach the surface and form condensation (see Figure 12 below). If an insulating type material such as a pillow is leaned against the exterior wall, condensation might form on the covered wall. The interior wall is cooler due to the insulative property of the pillow. Unfortunately the pillow would not resist the transfer of vapour to the wall. As the moist air migrates through the insulation and reaches the cooler wall, it may reach its dew point temperature, thus forming condensation (see Figure 13 below). If the wall behind the pillow is below freezing, frost may actually freeze the pillow to the wall.

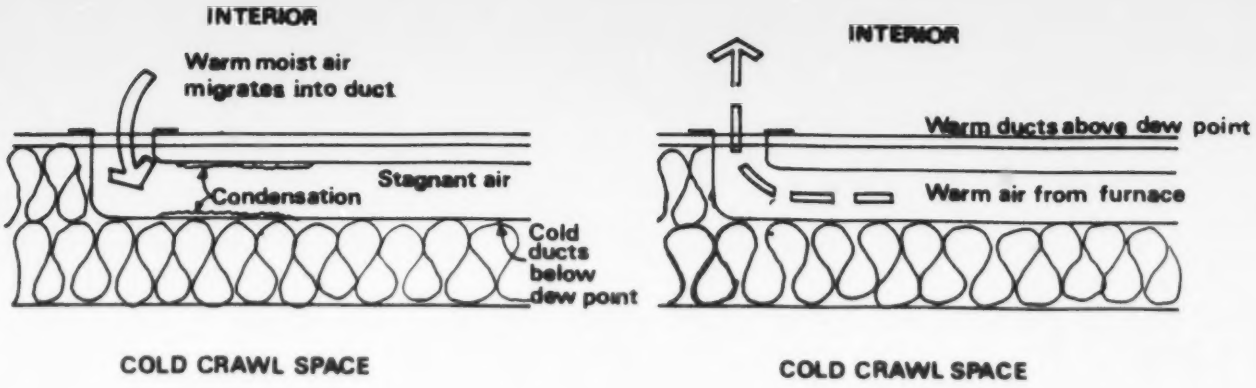
FIG. 14: Formation of condensation in floor ducts

Concealed condensation can also occur in air ducts in mobile homes. If the insulation protecting the ducts is inadequate, the furnace is infrequently used because the occupants are on holidays, or the space heating is supplied by portable heaters and/or fireplaces, the ducts can become quite cold. Without the warming and drying effects of furnace heat blowing through the ducts, indoor air may migrate into the ducts. If the ducts are sufficiently cool the dew point temperature may be reached to cause formation of condensation (see Figure 14 on page 55A). The results can cause the ducts and screws to rust and the condensation may leak through to saturate the insulation and other materials.

The obvious remedial measure to prevent the formation of condensation in air ducts during the use of wood stoves, is to turn on the furnace fan. The furnace fan will help circulated warm air in the ducts, thus raising the temperature higher than the dew point. Since tenant cooperation is not dependable, an automatic method of circulating the excess heat from one room to the rest of the house is needed. A differential thermostat purchased for approximately $100.00 can be used to turn on the furnace fan when the room with the wood stove is overheated and other rooms are cool. The differential thermostat compares the temperature between two sensors. When the temperature difference between the two sensors exceeds a certain set temperature, it sends a signal to turn on the furnace fan. The typical differential thermostat can be set between a 5°C to 20°C differential (see Figure 15 on page 55A).

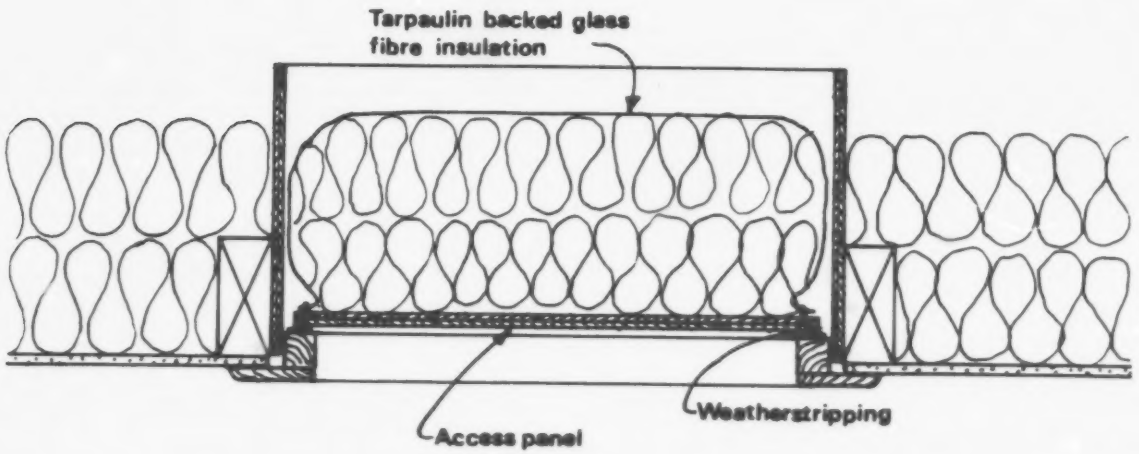
FIG. 18: Attic access hatch in ceiling

- air movement under rigid insulation on top of the access hatch,
- air gaps between the ceiling insulation and the hatch insulation,
- weatherstripping omitted or improperly installed, and
- weatherstripping not sufficiently compressed to provide an air seal.

If attic access hatches are to be installed in mobile homes, proper weatherstripping and the use of tarpaulin wrapped, glass fibre insulation on top of the hatch will provide an effective air seal and thermal insulation. Figure 18 below illustrates the proper details. A more effective method is to avoid penetrating the ceiling by locating the attic access hatch at the gable end. In this position, the ceiling is continuously sealed and insulated. The inconvenience of accessing the attic from the exterior is minimal since such access is rarely needed.
